# CONDITION SURVEY, WESTOVER AIR FORCE BASE, MASSACHUSETTS

R. D. Jackson

June 1973

Conducted by U. S. Army Engineer Waterways Experiment Station  
Soils and Pavements Laboratory  
Vicksburg, Mississippi

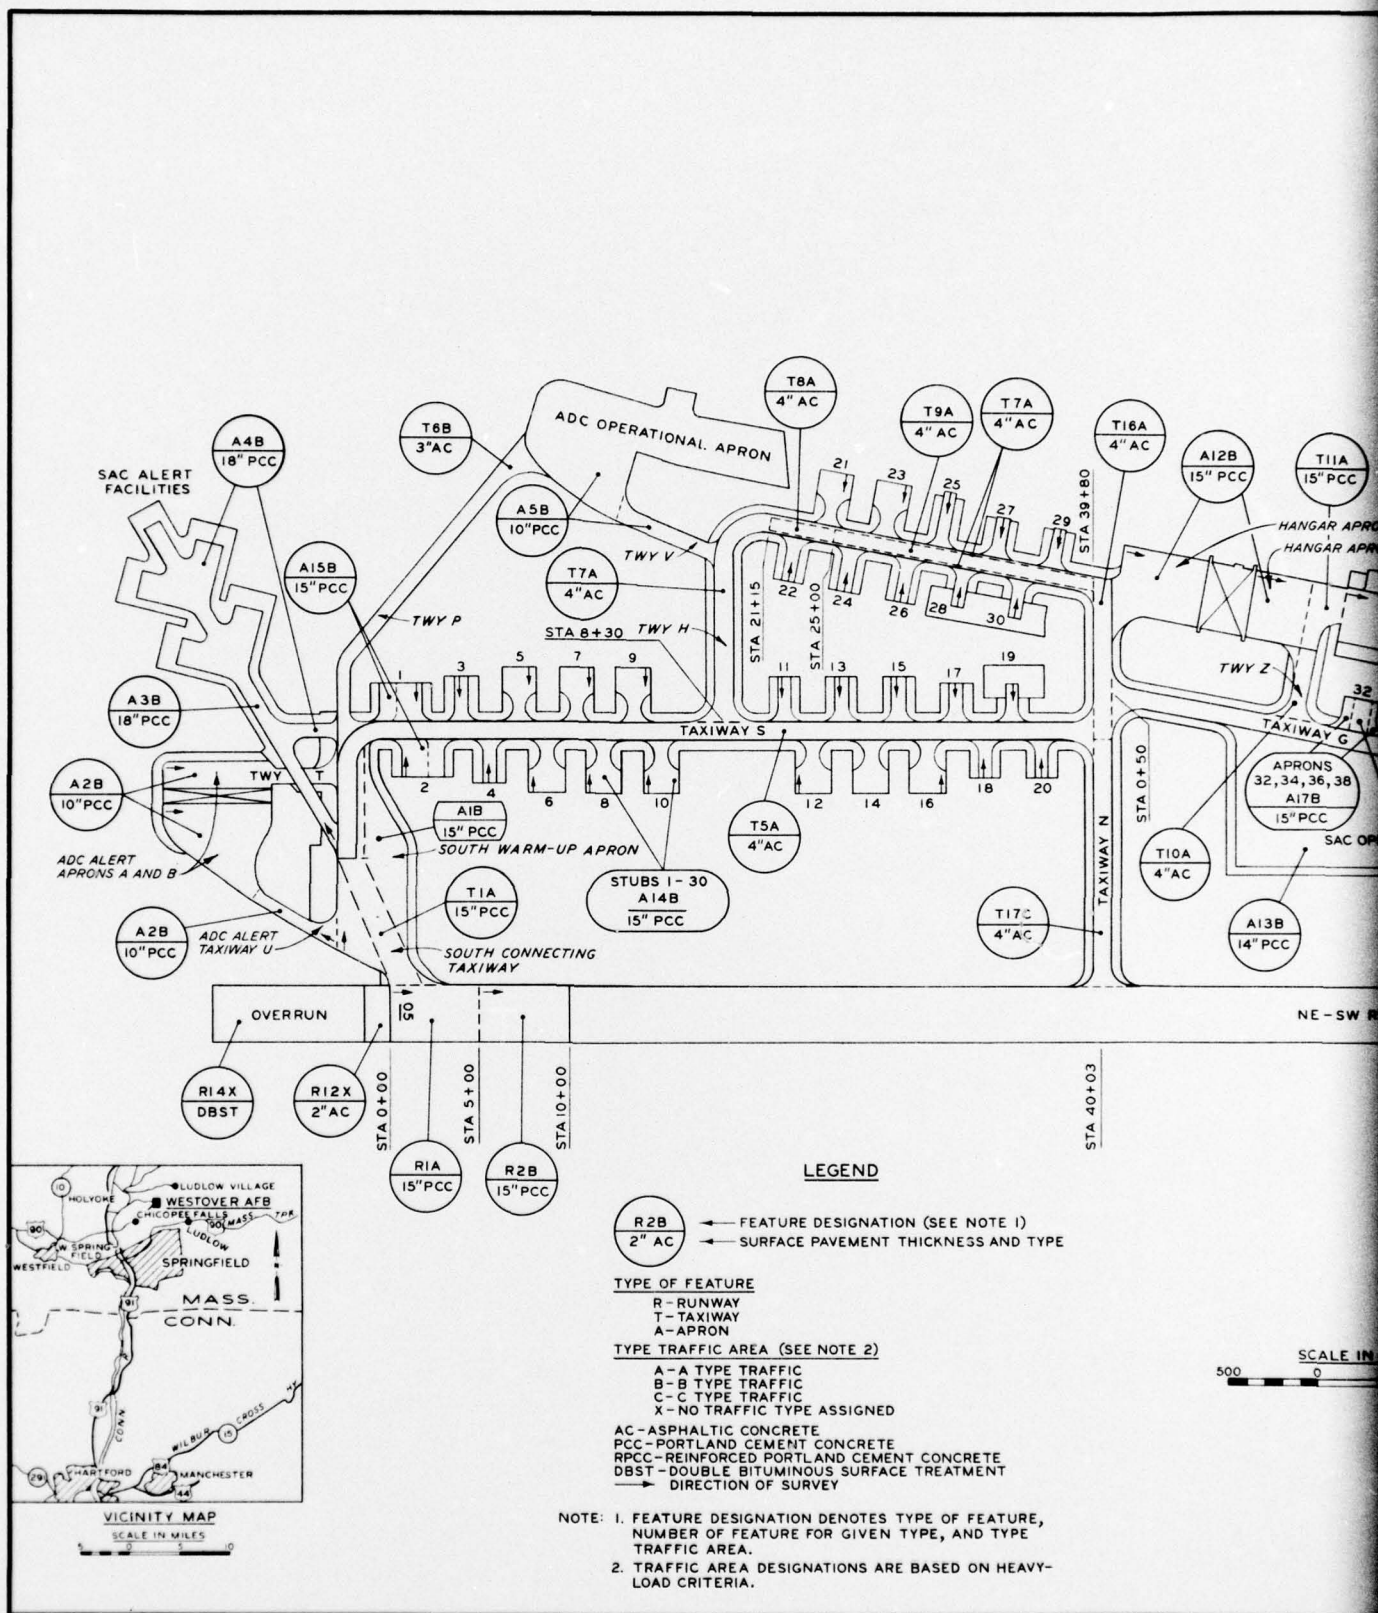
PLATE 1

4. WAFB is located in Hampden County, between South Hadley Falls and Chicopee Falls, Massachusetts. A vicinity map is shown in plates 1 and 2.

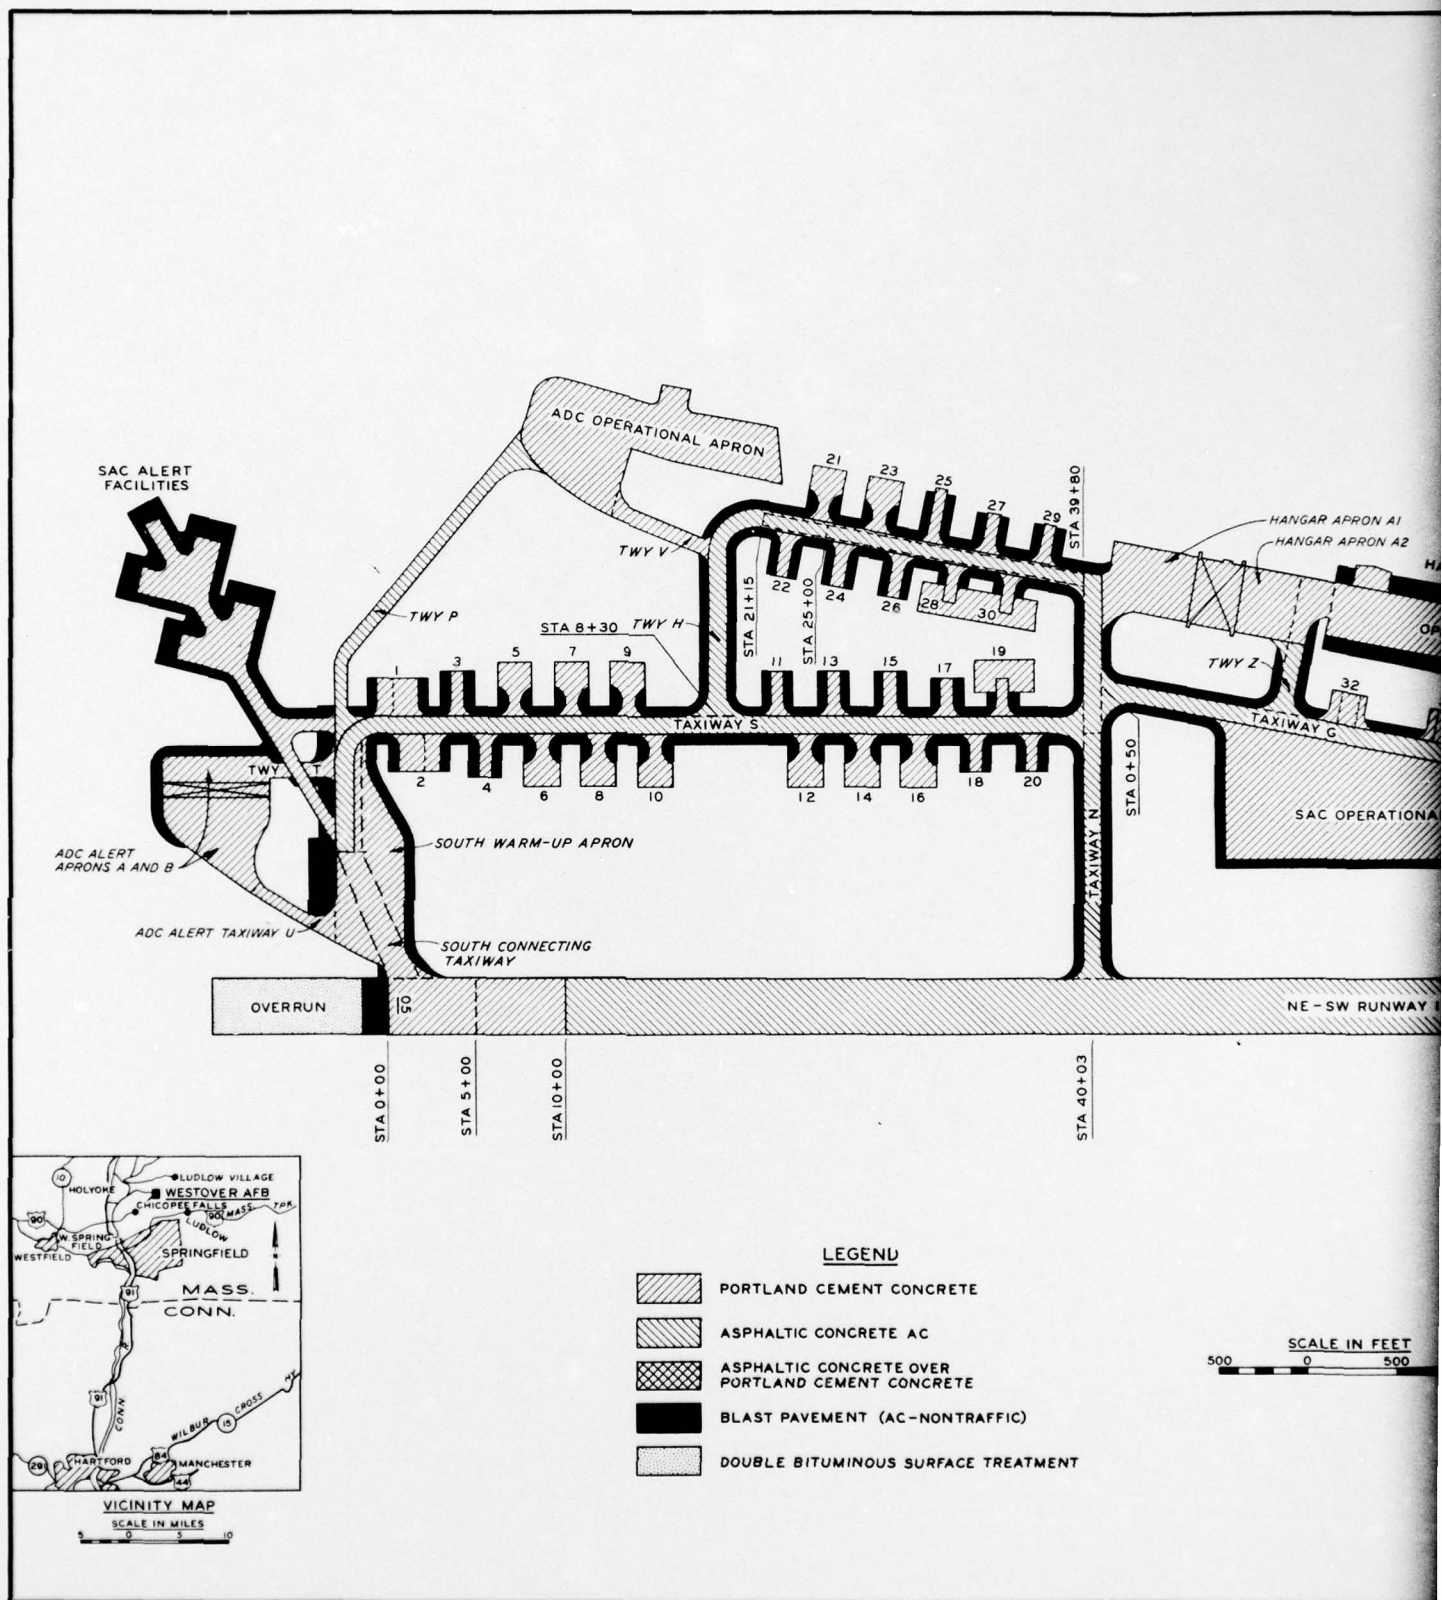
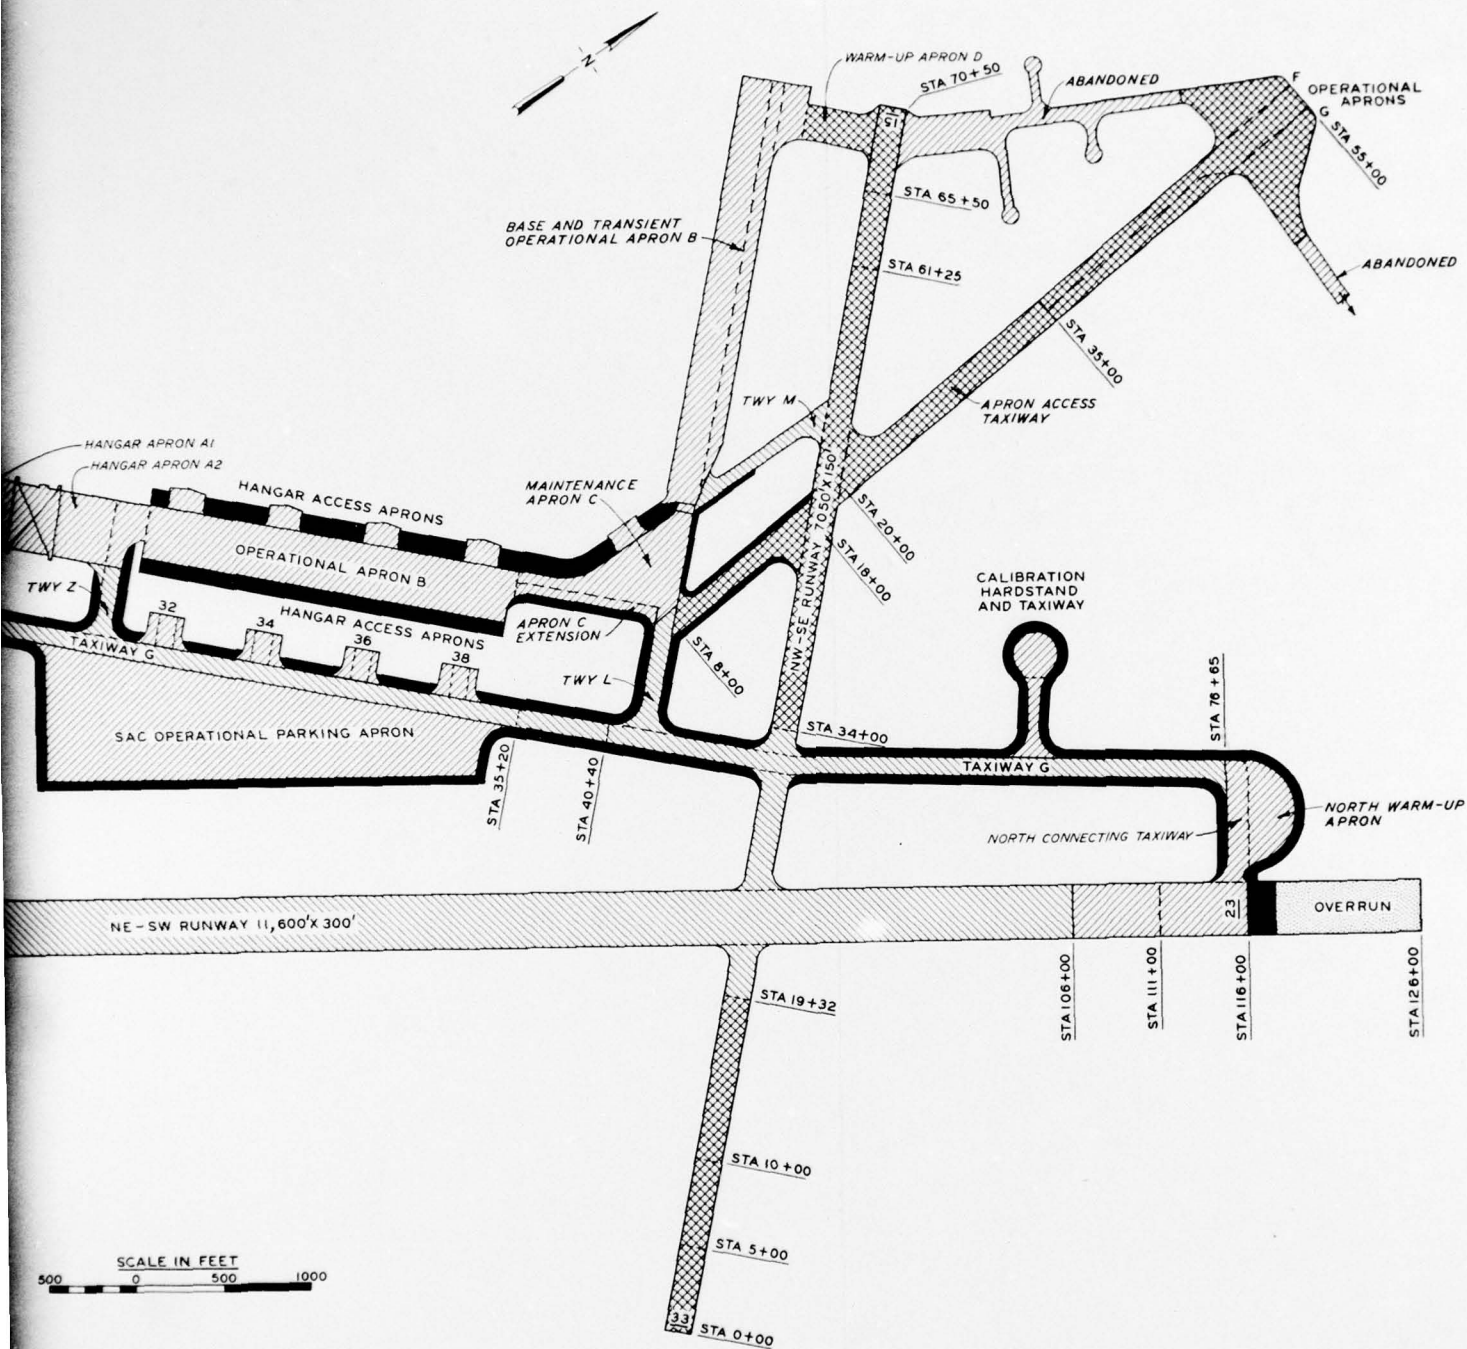
# WESTOVER AFB PAVEMENT PLAN

5. In August 1972, the airfield facilities consisted of a NE-SW (05-23) runway, a NW-SE (15-33) runway, a series of taxiways, aircraft parking stubs, hangar aprons, hangar access aprons, a maintenance apron, six warm-up aprons, an operational apron, a base and transient operational apron, a SAC operational parking apron, an Aerospace Defense Command (ADC) operational apron, ADC and SAC alert facilities, and a calibration hardstand. The NE-SW runway was 11,600 ft\* long and 300 ft wide; the NW-SE runway was 7,050 ft long and 150 ft wide; the taxiways were 75 ft wide, except for taxiways G and L, which were 100 ft wide; the aircraft parking stubs, the hangar aprons, the access aprons, the maintenance apron, and the warm-up aprons were of various sizes; the operational apron was 2,092 ft long and 312 ft wide; the base and transient operational apron was 250 ft wide and of varying length; the SAC operational parking apron, the ADC operational parking apron, the ADC operational apron, and the ADC and SAC alert facilities were irregular in shape; and the calibration hardstand was 275 ft in diameter. A layout of the airfield is shown in plate 1. A pavement plan indicating the type pavement on each facility is shown in plate 2.
